### ▲<sup>1</sup> ALLEGRO 1100/1300, MINI, 1100/1300

#### CLUTCH JUDDER

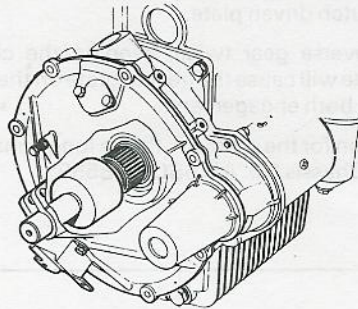
When investigating complaints of clutch judder it has been discovered that a possible cause is misalignment of the clutch cover. The following method of rectification is recommended.

NOTE: If the clutch cover will not enter the register due to fouling at the point arrowed in diagram 'A', machine approximately 0.040" from that point.

1. Remove the clutch cover, clutch and flywheel assembly.
2. Remove the clutch release bearing and shaft and throw out arm from the clutch cover.
3. Slide the aligning tool 18G 1247 onto the end of the crankshaft and slide the cover onto the tool. (As shown in the diagram below.)

4. Check to ensure the cover slides freely over the aligning tool into position without fouling. Refit at least four cover to flywheel housing bolts, equally spaced to hold the cover in position.
5. Drill two holes  $\frac{1}{8}$ " diameter through the cover and housing at 180° to each other and  $\frac{3}{16}$ " from the edge of the cover.

6. Remove the clutch cover and aligning tool.
7. Replace the clutch and flywheel assembly ensuring that the driven plate linings and primary gear oil seal are in good serviceable condition.
8. Reassemble the clutch cover and replace using two roll pins ( $\frac{1}{8}$ " x  $\frac{1}{4}$ "). If the roll pins are not available, use two pieces of  $\frac{1}{8}$ " dia. brazing rod as dowels. (these must be a snug fit in the holes to ensure correct alignment) then tighten the cover to flywheel housing bolts. (See Fig. B.)
