**▲⁸ MINOR 1000 RANGE
INABILITY TO SELECT GEARS**

**▲⁹ ROVER SD1 2000, 2300, 2400 DIESEL, 2600 AND 3500
IMPROVED CLUTCH SPECIFICATIONS**

**▲¹⁰ ROVER 2300 and 2600 1977→
DIFFICULT GEAR SELECTION**

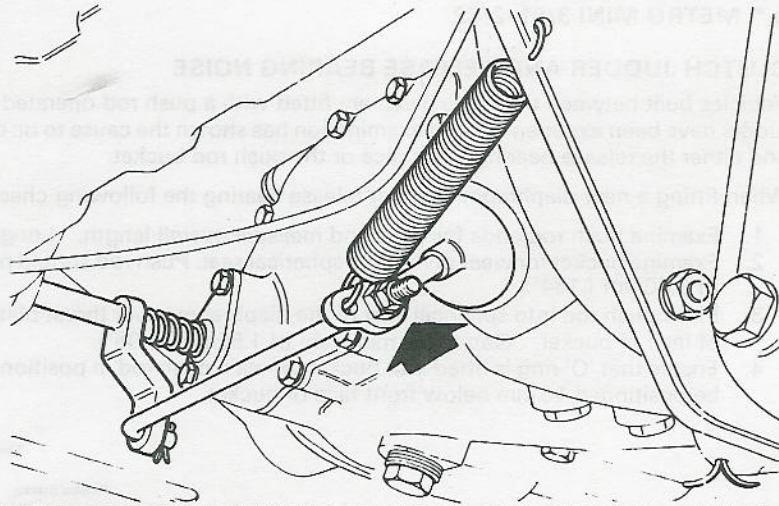
Insufficient release bearing/release plate clearance on the above vehicles can cause an overstroking condition leading to the above complaint. Other problems could be clutch slip or driven plate damage.

ADJUST HERE TO SET PEDAL FREE TRAVEL TO 34.9–38.1 mm ($1\frac{3}{8}$ "– $1\frac{1}{2}$ ".)

Correct clearance is achieved by setting the clutch pedal free travel, which for vehicles with 1098 cc. engines must be 35–38 mm ($1\frac{3}{8}$ "– $1\frac{1}{2}$ " measured at the pedal pad. (For earlier vehicles prior to the 1098 cc. engine the setting must be 19 mm ($\frac{3}{4}$ ".))

Set the pedal free travel by adjustment of the clutch operation rod as shown in the illustration.

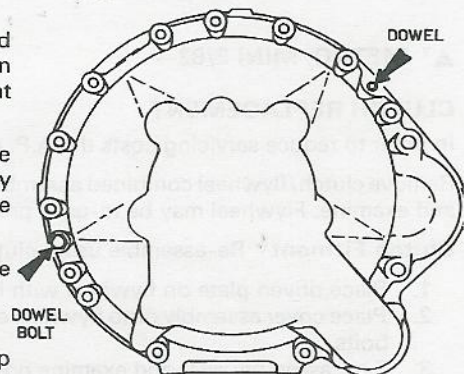
Examination of clutch assemblies returned for these complaints has revealed excessive wear on the diaphragm spring fingers and driven plates with broken centres. Investigation has shown this type of failure to be caused by misalignment between the engine and gearbox.

Correct alignment of the engine and gearbox on these vehicles is achieved by the use of a dowel and a special dowel bolt. It has been found on some vehicles, especially those where the engine or gearbox may have been removed previously; that the dowel and/or bolt have been either incorrectly fitted or omitted.

Before re-assembly of the gearbox to engine is carried out check the adaptor plate for flatness or distortion, then carry out the following procedure:

1. Align gearbox input shaft with driven plate splined hub.
2. Slide input shaft into splined hub and locate bellhousing on the dowel in top right hand of the casing making sure that the dowel is not pushed back through the adaptor plate. (See diagram.)
3. Locate and fit dowel bolt in its correct position in the lower left hand side of the bellhousing and refit the locking nut. (See diagram.)
4. Refit the remaining bolts and nuts.

The dowel bolt is the longest bolt and passes right through the bellhousing and crankcase flanges. This bolt should be a close fit in the bellhousing and may have to be lightly tapped with a hammer for its removal and re-fitment.

If it is suspected that incorrect dowels or dowel bolts have been used previously, or omitted, new parts should be obtained.
