RELEASE BEARING CARRIER

DIFFICULT GEAR ENGAGEMENT

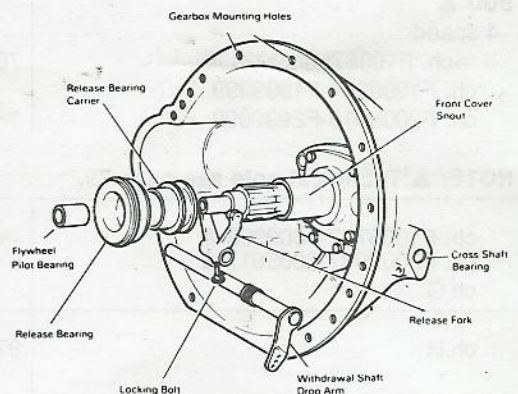
1. Examine the gearbox mounting holes for wear or ovality which may allow the gearbox to drop from its original mounted position and cause misalignment of the release bearing.

2. The release bearing carrier must be a snug fit on the front cover snout with no tight spots or excessive play. The carrier groove should be unworn, particularly on the front face where contacted by the release fork trunnions.

3. The release fork must be held securely to the withdrawal shaft by the locking bolt, no play whatever is permissible at this point. The release fork trunnions should be round and unworn. (Alternative designs of release mechanism use rectangular metal blocks or round end caps on the trunnions.)

4. Carefully examine the cross shaft bearings for wear or lack of lubrication, particularly on the withdrawal arm side.
5. Check the release bearing which must revolve smoothly while being turned under firm pressure between the hands.

6. Critically examine the flywheel pilot bearing, looking for wear or 'bellmouthing' however slight.

Should any of these components be found unserviceable then the parts must be replaced.

Lightly smear the front cover snout and the release fork trunnions with Lockheed High Temperature Anti-Seize Copper Grease.
