SEAT	SEAT	SEAT	CLUTCH KIT	COVER ASSEMBLY	DRIVEN PLATE	RELEASE BEARING

SEAT - continued

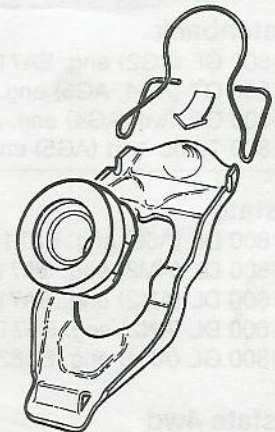
▲¹ CLUTCH RELEASE BEARING HD2466

Your attention is drawn to the need to ensure correct installation of the release bearing on later Skoda vehicles with the pressed steel clutch release arm.

A number of clutch actuation problems have been attributed to incorrect fitting of the release bearing retaining spring.

To ensure correct fitment the following procedure should be followed.

1. With the clutch release arm removed from the vehicle push the retaining spring onto the top of the arm. Ensure that the two short arms of the retaining spring are behind the release arm.
2. Place bearing in position in the location slot in the release arm.
3. Push the retaining spring along the release arm until the loop at the top is seen to engage in retaining groove in the release bearing.
4. Check that the short arms of the retaining spring are located in the indents formed in the release arm by the pivots for the release bearing.
